# No access to the local unit

Make sure that the connectivity is provided between the control center and the device's installation point. If the access is missing only for the InfiNet device, further actions must be performed at the device's installation site.

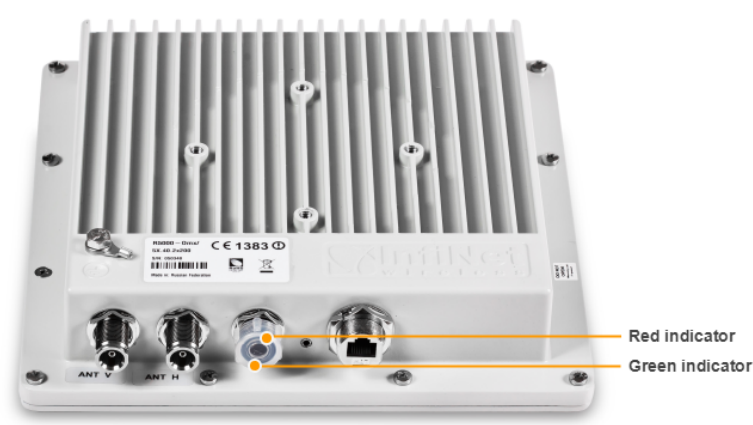
The R5000-Mmx, R5000-Qmx, and R5000-Omx have two LED indicators (red and green) located in the console port. These indicators help to monitor the device's status during the installation. The correspondence between the state of the indicators and the current device state is shown in the table below.

Figure - LED indication of R5000-Mmx, R5000-Qmx, R500-Omx devices

| Red indicator | Green indicator | Device status |

| Off | Off | The device is switched off or in the process of start-up booting |
| Off | Blinking | The device has booted, but it has no radio connection. Searching for another device to establish the radio connection |
| Blinking | On | Radio connection established. The more data is being transmitted through the radio channel the more frequently the red indicator is blinking |
