No access to the local unit

- Indicators
 - R5000-Mmx, R5000-Qmx and R5000-Omx
 - R5000-Smn and R5000-Lmn
- Access recovery
- Checking the status of the Ethernet interface
 - Wired interface statistics
 - Duplex mode

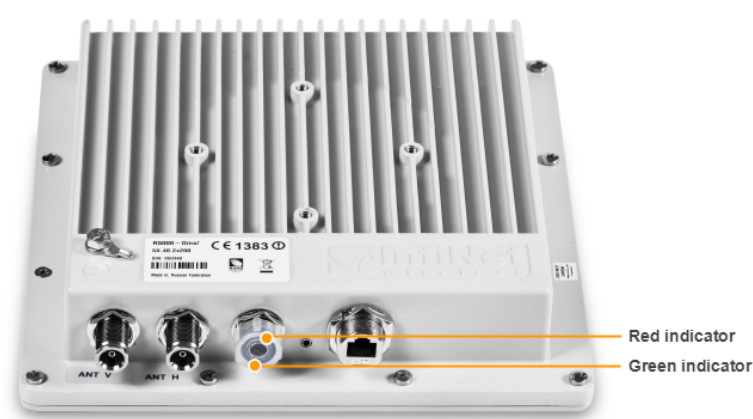
The R5000-Mmx, R5000-Qmx, and R5000-Omx have two LED indicators (red and green) located in the console port. These indicators help to monitor the device's status during the installation. The correspondence between the state of the indicators and the current device state is shown in the table below.

Figure - LED indication of R5000-Mmx, R5000-Qmx, R500-Omx devices

Red indicator	Green indicator	Device status
---------------	-----------------	---------------

Off	Off	The device is switched off or in the process of start-up booting
Off	Blinking	The device has booted, but it has no radio connection. Searching for another device to establish the radio connection
Blinking	On	Radio connection established. The more data is being transmitted through the radio channel the more frequently the red indicator is blinking
