The wireless link throughput is lower than expected

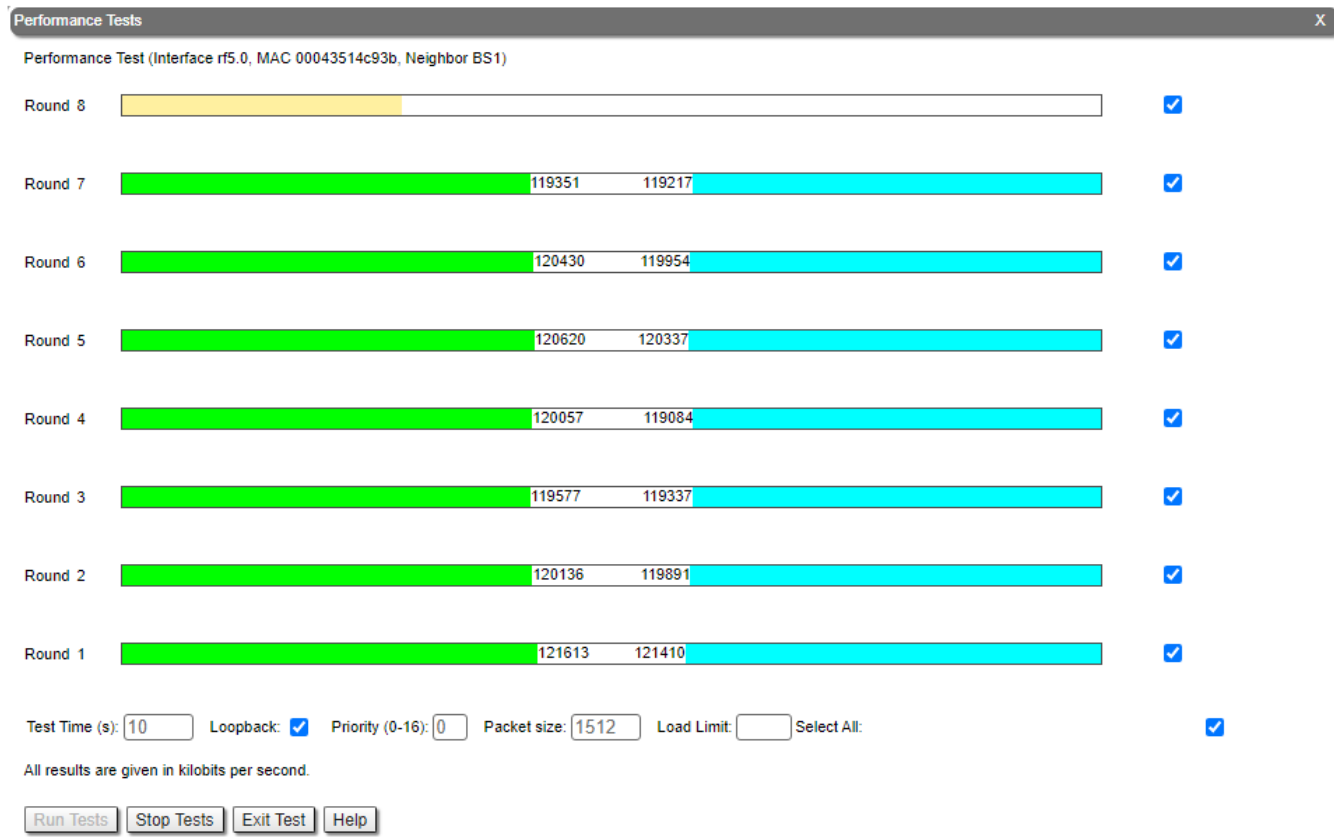
The throughput test can be performed with the "Performance Tests" tool built into the web interface, in the section "Device status" → "Link statistics for the rf5.0 interface". This tool generates test traffic between the devices and it allows to obtain data about the real link throughput both in one direction and in a two-way manner. The throughput evaluation is performed using traffic with the specified priority without taking into account the service traffic required to maintain the link operational. To exclude the influence of the data traffic on the test's result, it is recommended to set the highest priority for the test traffic (at least 15). When the MINT testing mode is enabled (the "use MINT" checkbox), performance tests are always performed on the highest modulation, otherwise testing will be performed on each modulation available. The detailed description of the parameters and the performance test settings are available in the "Device Status menu" article.

Figure - Performance tests

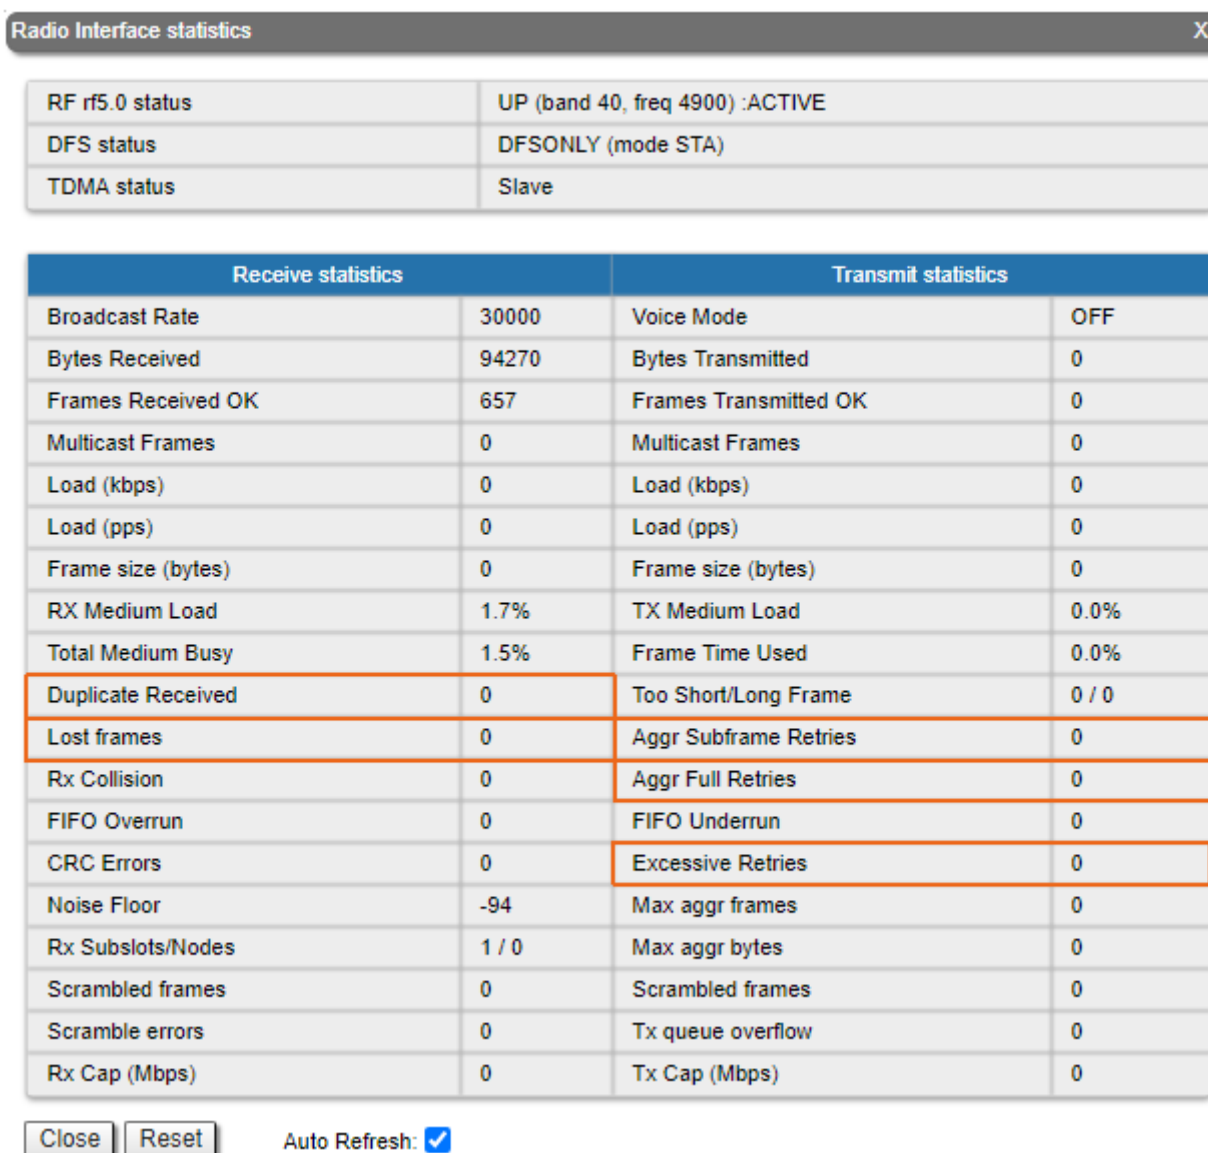
In case of a high retries level, use the built-in [statistics tools](#). The "General statistics" section contains information about the link load, queue overflow, etc..

Figure - General statistics

- "Lost Frames" - the number of frames that were not received by the device, even after retrying.
- "Duplicates Received" - the number of frames that were received several times because the other side did not receive an acknowledgment of the frame.
- "Aggr Subframe Retries" and "Aggr Full Retries" - the number of frames that the device has sent several times because the other side did not acknowledge the receipt.
- "Excessive Retries" - the number of frames that failed to be sent after all the retry attempts.
