# No access to the local unit

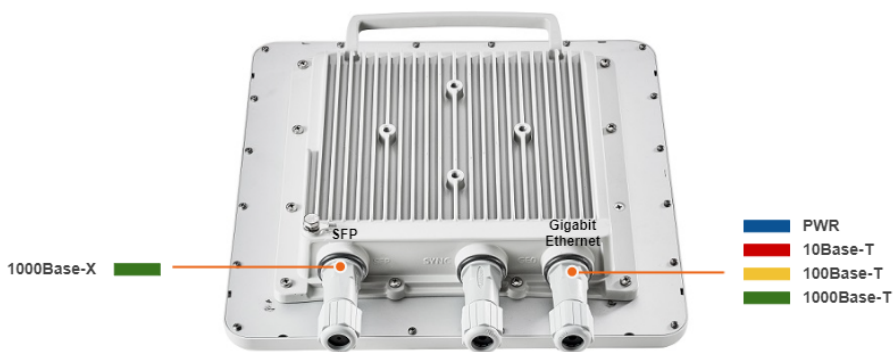
LED indicators on the InfiMAN Evolution family base station sectors are located in the the cable glands ports. These indicators help to monitor the device's status during the installation. The correspondence between the state of the indicators and the current device state is shown in the table below.

Figure - LED indication of InfiMAN Evolution BS

LED	State	Status	Description
Gigabit Ethernet	Flash	Initialization	The LEDs on both ports light up with white on second. Then LEDs check is performed: red, blue, green are lightened up sequentially.

SFP	Flash	Loading	Only for Gigabit Ethernet port: at the beginning green is lightened a few seconds, on the second loading stage switches to blue.
	ON/Blue	Power	Only for Gigabit Ethernet port.
	ON/Red	Speed 10 Mbps	Only for Gigabit Ethernet port.
	ON /Yellow	Speed 100 Mbps	Only for Gigabit Ethernet port.
	ON /Green	Speed 1000 Mbps	
	ON /Green	ERConsole stage	Port with the established link lights up with green, the second port remains blue.

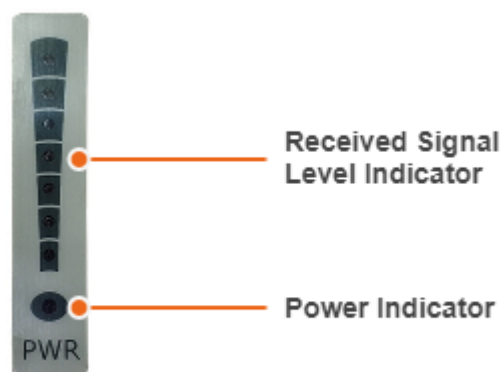
InfiMAN Evolution ST and InfiLINK Evolution devices have a LED indicator set located at the back of each device, displaying the current device state.

**Figure - LED indication of InfiMAN Evoluton ST, InfiLINK Evolution**

PWR - power indicators will light red when the device is connected to a power source, yellow when 10/100 Mbps wired connection appears and green when 1000 Mbps wired connection appears. Other indicators are used to perform coarse antenna alignment. The more indicators are on, the better wireless connection is established. The blinking indicator means an intermediate state. The more often the indicator blinks the higher level connection is established.

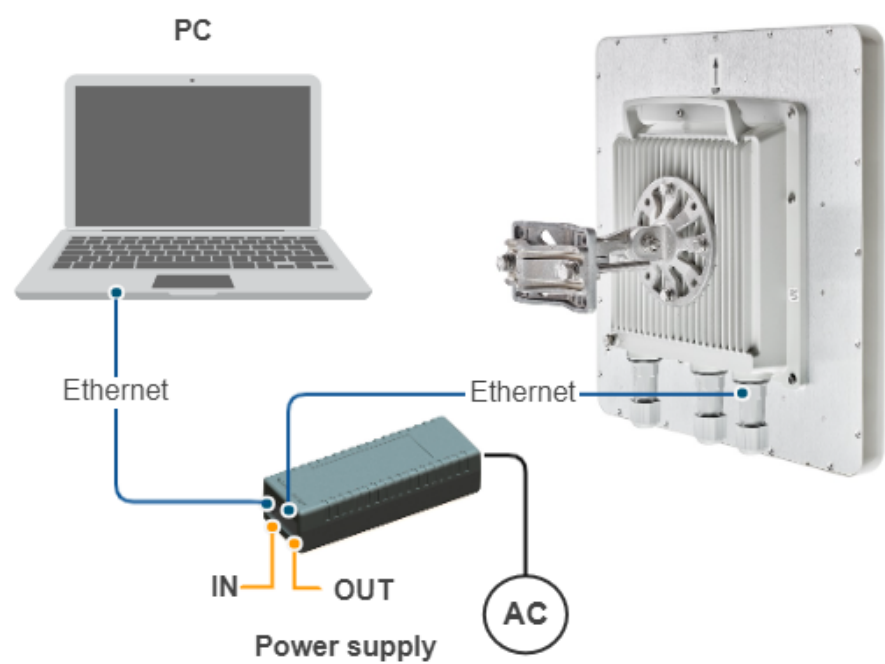
If the power indicator is on and there is connection via the Ethernet interface, connect to the device directly as it is shown in the scheme below. Make sure that the IP address of the PC is in the same subnet as the IP address of the device. You can restore the IP address and reset the device to the factory settings using the ERConsole utility.

Figure - The recommended connection scheme
