The wireless link throughput is lower than expected

- Performance tests
- Wireless link status
 - Link statistics on the rf6.0 interface
 - Radio statistics
 - QoS statistics
- Statistics graphs
- Device status
- Last reboot reason
- System log
- Antenna alignment

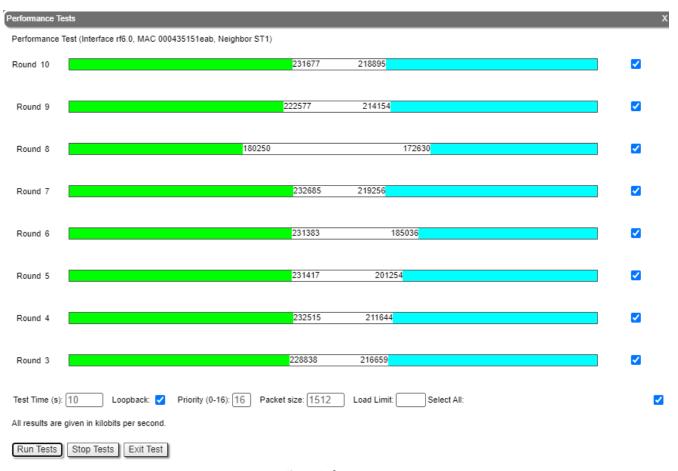
Figure - Performance tests

The throughput test can be performed with the "Performance Tests" tool built into the web interface, in the section "Device status" → "Link statistics for the rf6.0 interface". This tool generates test traffic between the devices and it allows to obtain data about the real link throughput both in one direction and in a two-way manner. The throughput evaluation is performed using traffic with the specified priority without taking into account the service traffic required to maintain the link operational. To exclude the influence of the data traffic on the test's result, it is recommended to set the highest priority for the test traffic (at least 15). Performance tests are always performed on the highest modulation, the detailed description of the parameters and the performance test settings are available in the "Device Status menu" article.

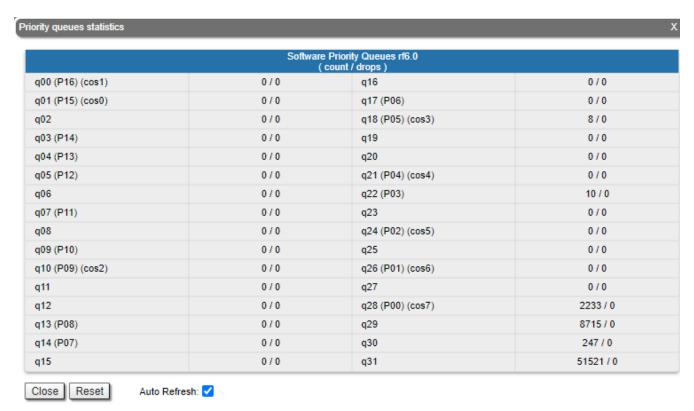
Figure - QoS statistics

The "QoS statistics" section provides information about the transmitted and dropped packets in each priority queue configured on the device. Drops present in the traffic processing queues indicate that the throughput threshold has been exceeded. Losses in queue q00 (P16) are acceptable because this queue contains performance test data.

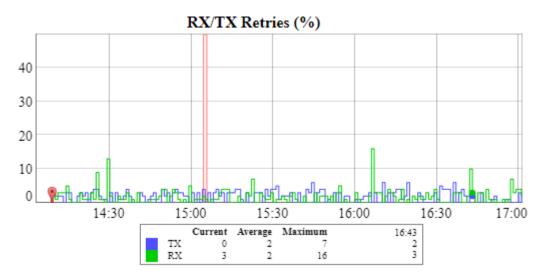
Figure - Statistics graphs

If the link has deteriorated during its operation, having the initial parameters corresponding to the calculated ones, it is necessary to find out when the problem has occured. Use the "Statistics graphs" tool to determine when or how often the problem occurs by changing the display options.
