No access to the local unit

Make sure that the connectivity is provided between the control center and the device's installation point. If the access is missing only for the InfiNet device, further actions must be performed at the device's installation site.

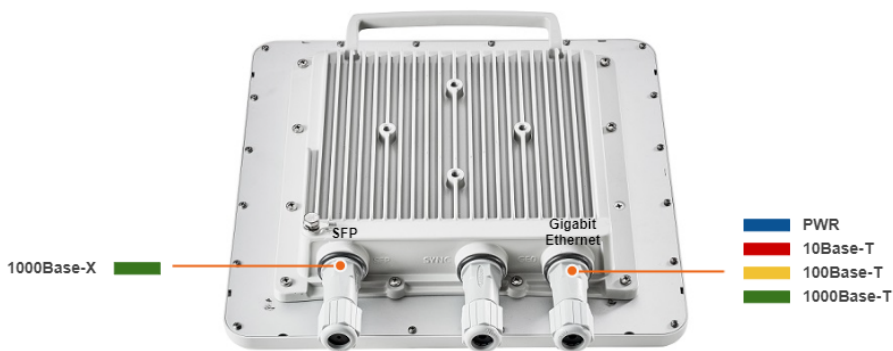
LED indicators on the InfiMAN Evolution family base station sectors are located in the the cable glands ports. These indicators help to monitor the device's status during the installation. The correspondence between the state of the indicators and the current device state is shown in the table below.

Figure - LED indication of InfiMAN Evolution BS

LED	State	Status	Description
Gigabit Ethernet SFP	Flash	Initialization	The LEDs on both ports light up with white on second. Then LEDs check is performed: red, blue, green are lightened up sequentially.
	Flash	Loading	Only for Gigabit Ethernet port: at the beginning green is lightened a few seconds, on the second loading stage switches to blue.

ON/Blue	Power	Only for Gigabit Ethernet port.
	ON/Red	Speed 10 Mbps	Only for Gigabit Ethernet port.
	ON /Yellow	Speed 100 Mbps	Only for Gigabit Ethernet port.
	ON /Green	Speed 1000 Mbps	
	ON /Green	ERConsole stage	Port with the established link lights up with green, the second port remains blue.

Table - LEDs modes and device status of InfiMAN Evoluton BS

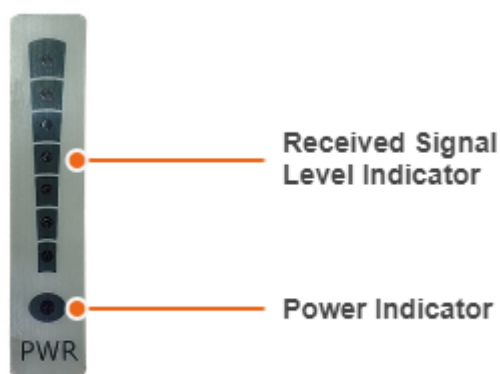
InfiMAN Evolution ST and InfiLINK Evolution devices have a LED indicator set located at the back of each device, displaying the current device state.

Figure - LED indication of InfiMAN Evoluton ST, InfiLINK Evolution

PWR - power indicators will light red when the device is connected to a power source, yellow when 10/100 Mbps wired connection appears and green when 1000 Mbps wired connection appears. Other indicators are used to perform coarse antenna alignment. The more indicators are on, the better wireless connection is established. The blinking indicator means an intermediate state. The more often the indicator blinks the higher level connection is established.
