The wireless link throughput is lower than expected

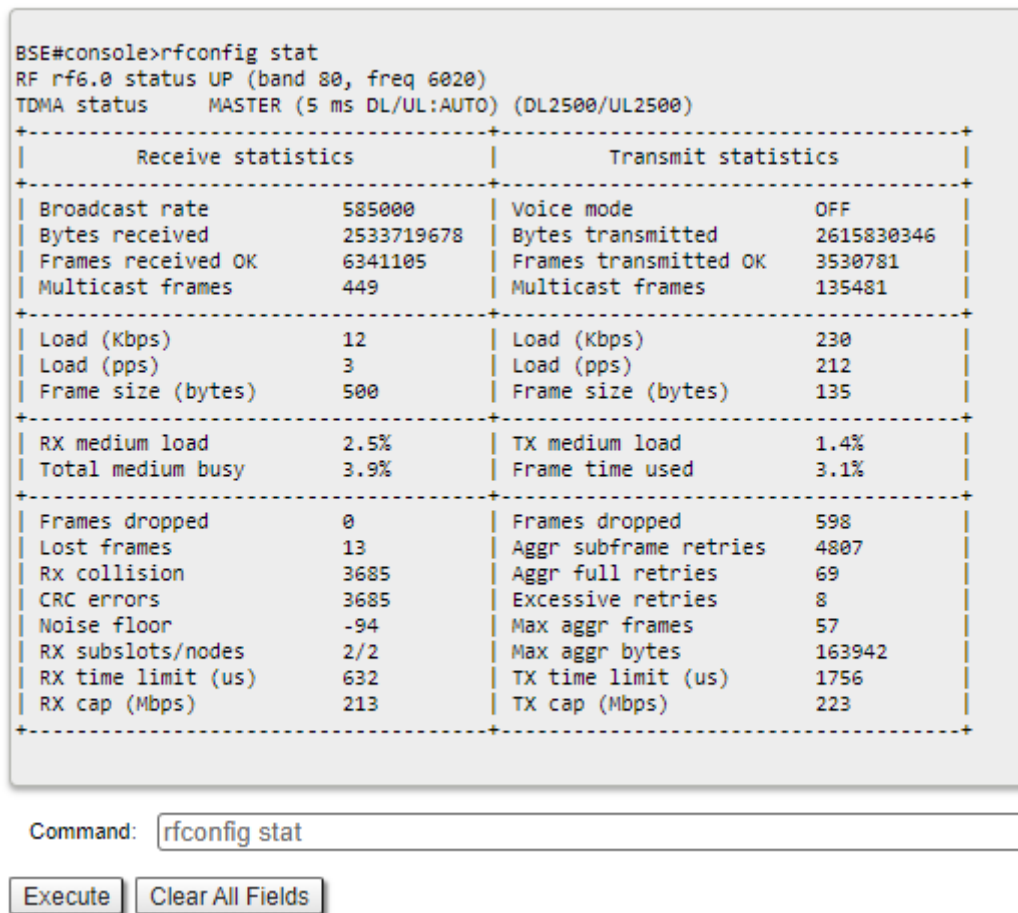
Figure - General statistics

To display statistics via the command line interface, use the ""`rfconfig stat`"" command.

Pay attention to the following indicators:

- "Lost Frames" - the number of frames that were not received by the device, even after retrying.
- "Aggr Subframe Retries" and "Aggr Full Retries" - the number of frames that the device has sent several times because the other side did not acknowledge the receipt.
- "Excessive Retries" - the number of frames that failed to be sent after all the retry attempts.

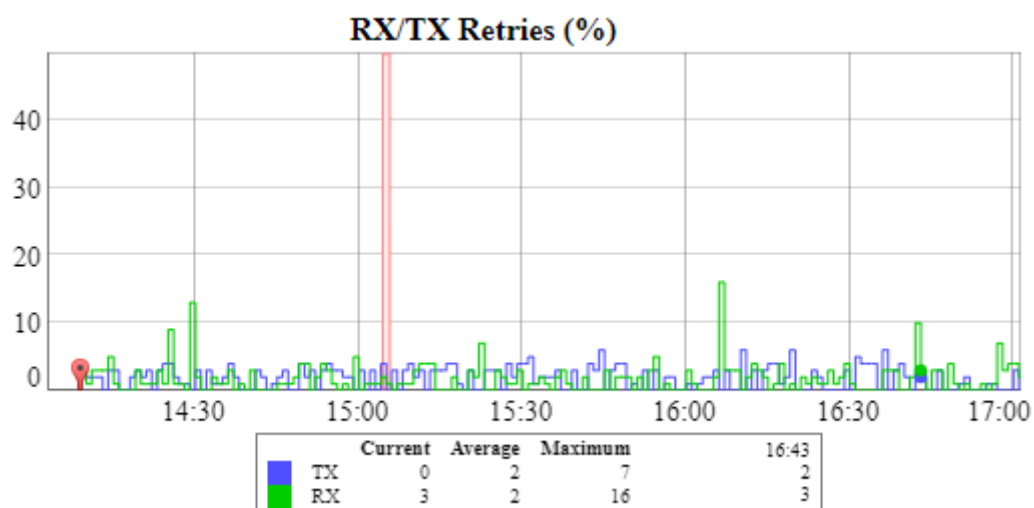
Figure - Statistics graphs

If the link has deteriorated during its operation, having the initial parameters corresponding to the calculated ones, it is necessary to find out when the problem has occurred. Use the "Statistics graphs" tool to determine when or how often the problem occurs by changing the display options.
